**Verify if the free stroke will disappear by performing the air venting test.**

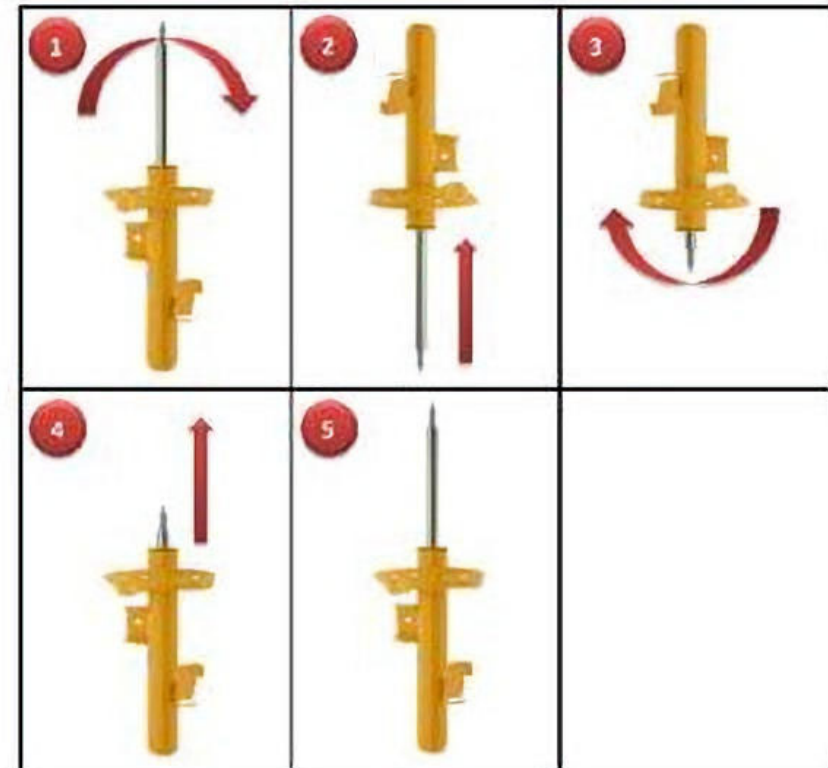
Step 1: Start position. Rotate the shock absorber 180 degrees (upside down)

Step 2: Hold this positioning for 5 seconds so the air has time to rise. Now fully compress the piston rod. This way the air will be pushed out of the inner tube through the foot valve.

Step 3: Rotate the shock absorber 180 degrees while keeping the piston rod compressed.

Step 4: Hold this positioning for 5 seconds so the air has time to rise. Now fully pull the piston rod outwards. By doing this the air is in the top of the shock absorber between the inner and outer tube and only oil is sucked in the inner tube.

Step 5: Final position. Repeat this sequence several times (e.g. 5 times). Please verify if the free-stroke is eliminated.

A free stroke could be caused by air which is trapped within the inner tube, whereas it should be located between the outer and inner tube. If this is the case, you can simply relocate the air by performing the following test.
